Newsletter following Community Liaison Group Meeting

5.30pm, Wednesday 14 November 2012

Road Realignment

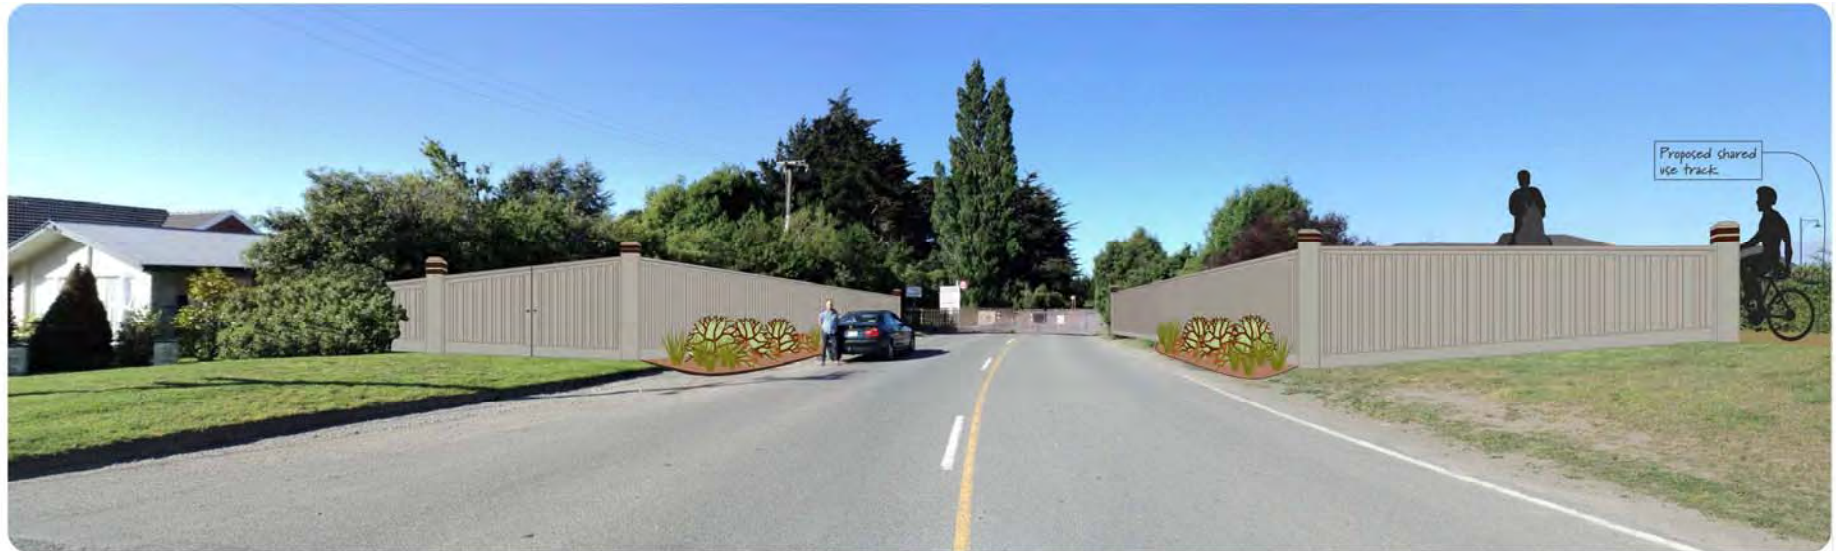
Burwood Landfill & Burwood Resource Recovery Access Road Proposed Fence - Artist's Impression

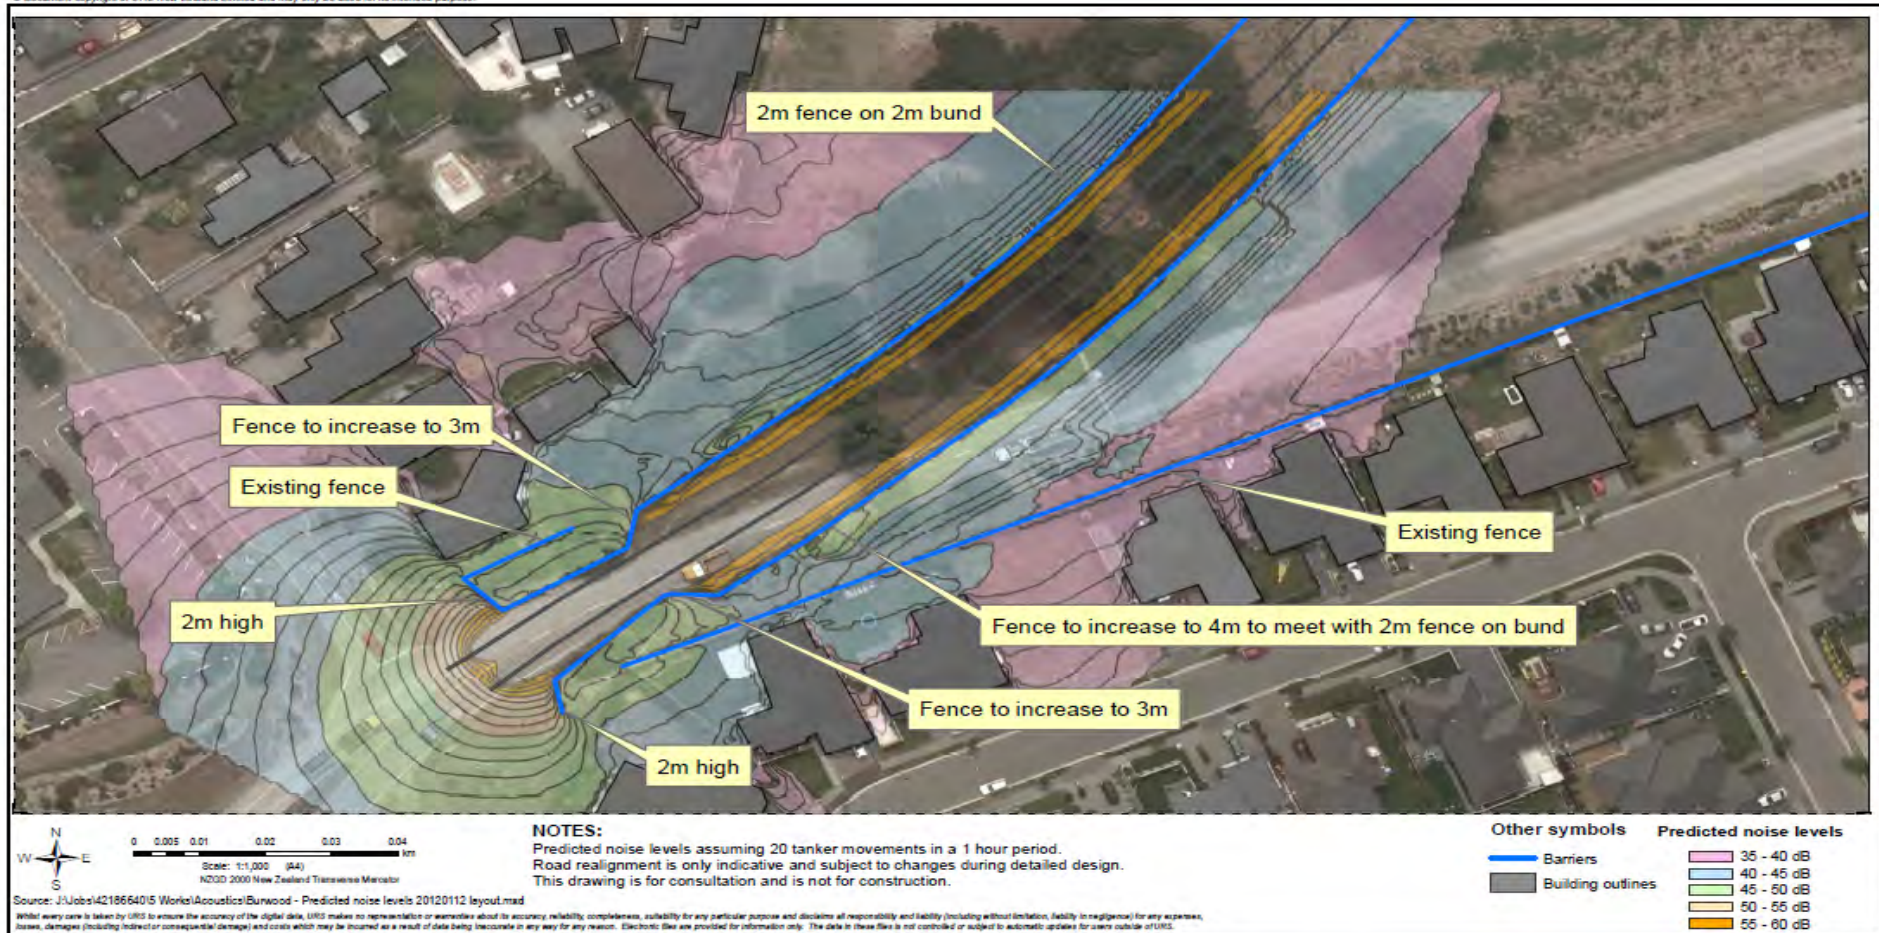
BARRIER CONCEPT - PREDICTED NOISE LEVELS

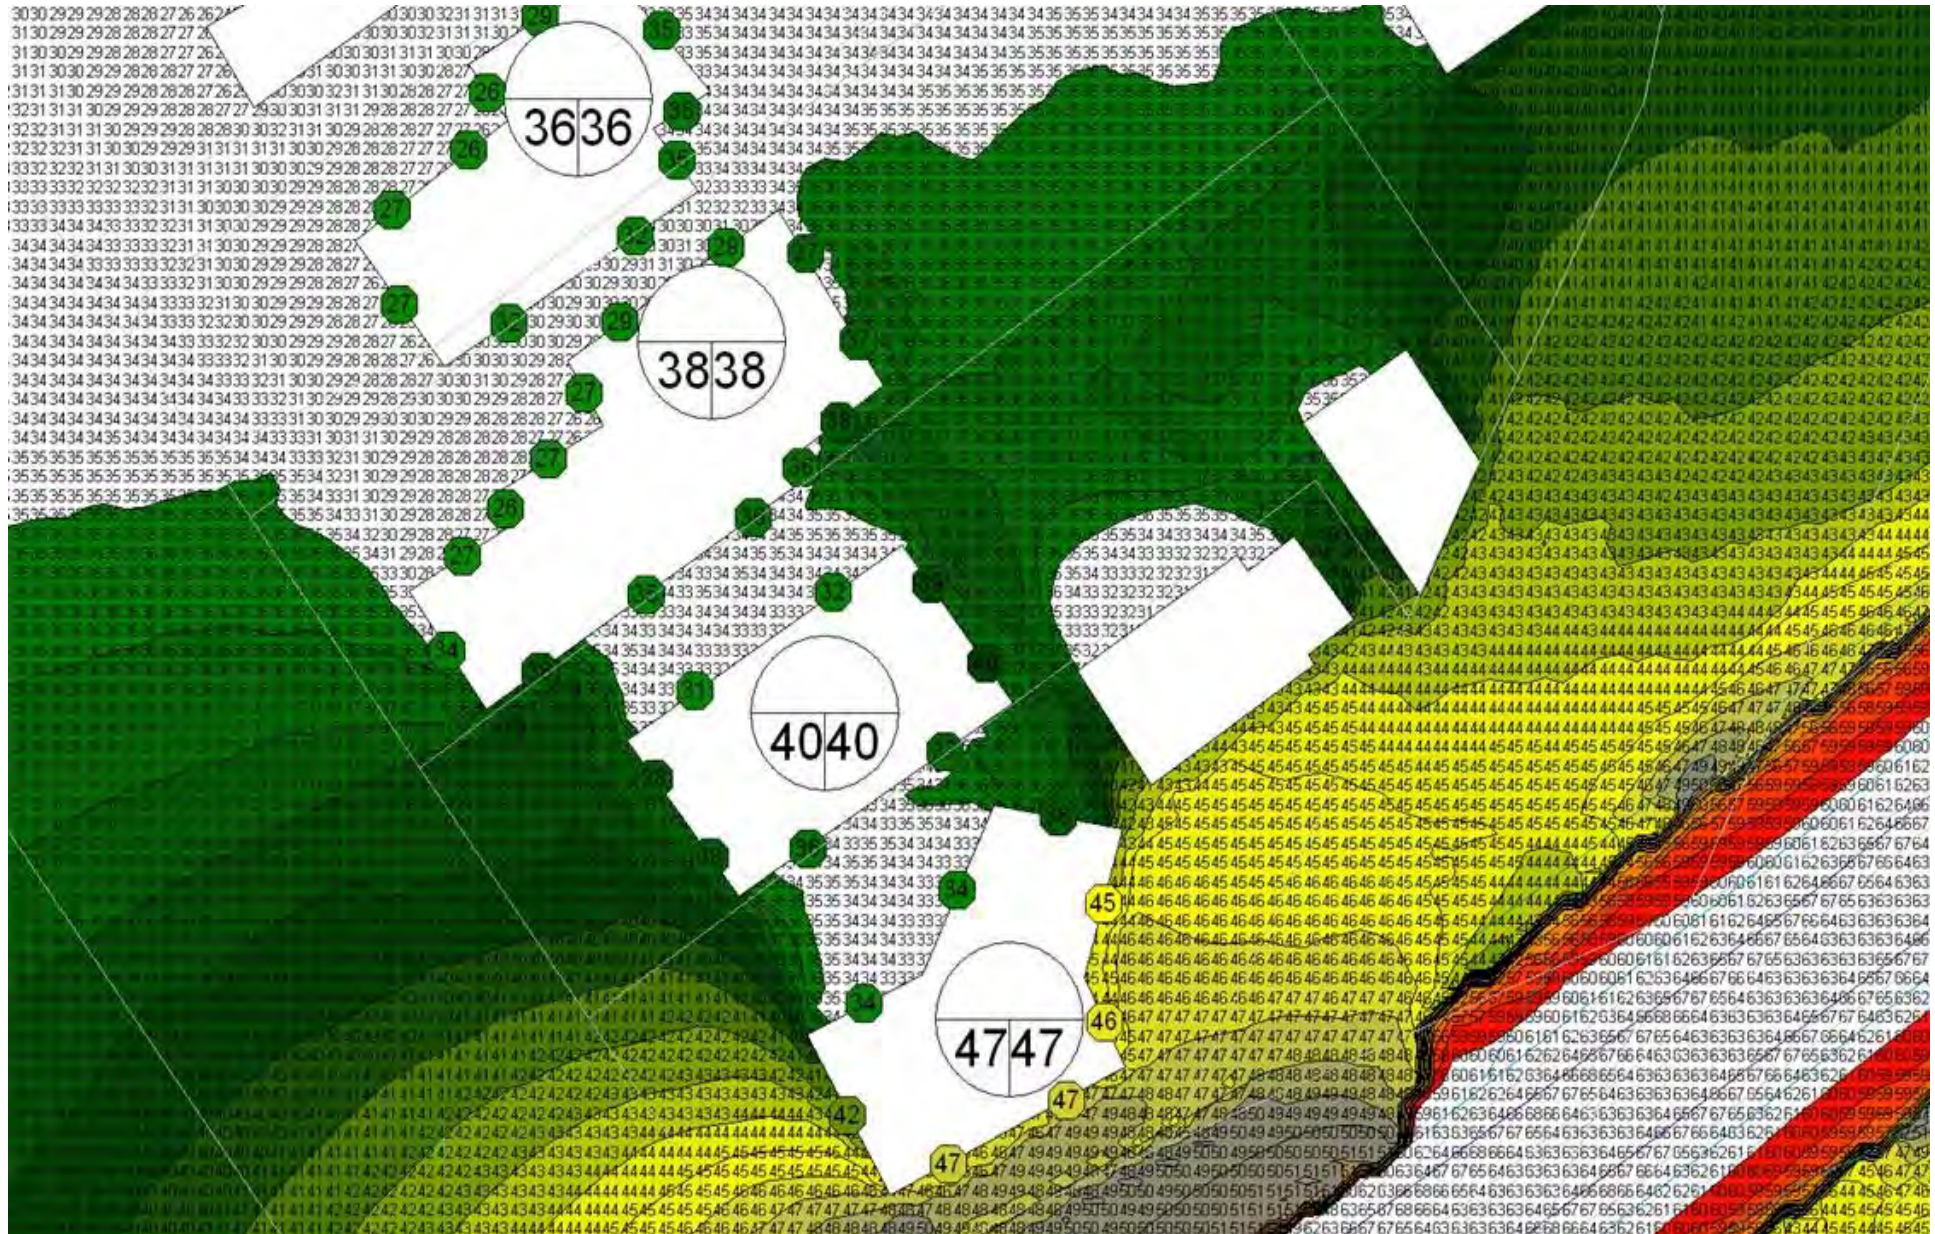
Noise Contours

- Bund on southern side of the new road extended to weigh station.
- Bund on north side extended to border of established stand of trees towards kiosk.
- Seven trees to be removed, but dominant stand of macrocapas retained to lessen impact.
